DIVISION Power Systems
TM 7972:70-640
DATE 25 August 1970
W.O. 1475-78-2000

TECHNICAL MEMORANDUM

TITLE: Evaluation of SNAP 8 Bare Refractory Double Containment Boiler No. 2
After 8700 Hours of Operation

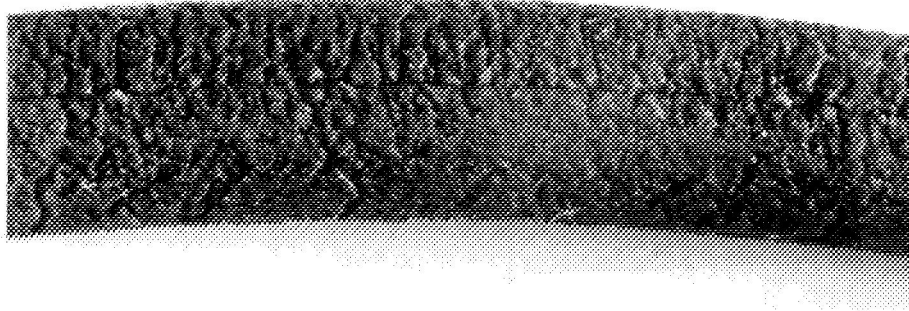
The area below the weld where the tube had been rolled into the header appeared satisfactory from a metallurgical standpoint, Figure 19. No evidence of incipient failure or other deleterious effects were observed. Although the rolled area appeared to provide some support of the tube by the header, there was not intimate contact along the entire rolled area between the tube and the header.

Figure 19 - Configuration of Ta tube where it was rolled into the Hg outlet header during boiler fabrication.
